# Status of FE-B Flex2 Module Testing

*K. Einsweiler, LBNL*

## Status of IZM FE-B Module assembled with Flex2:

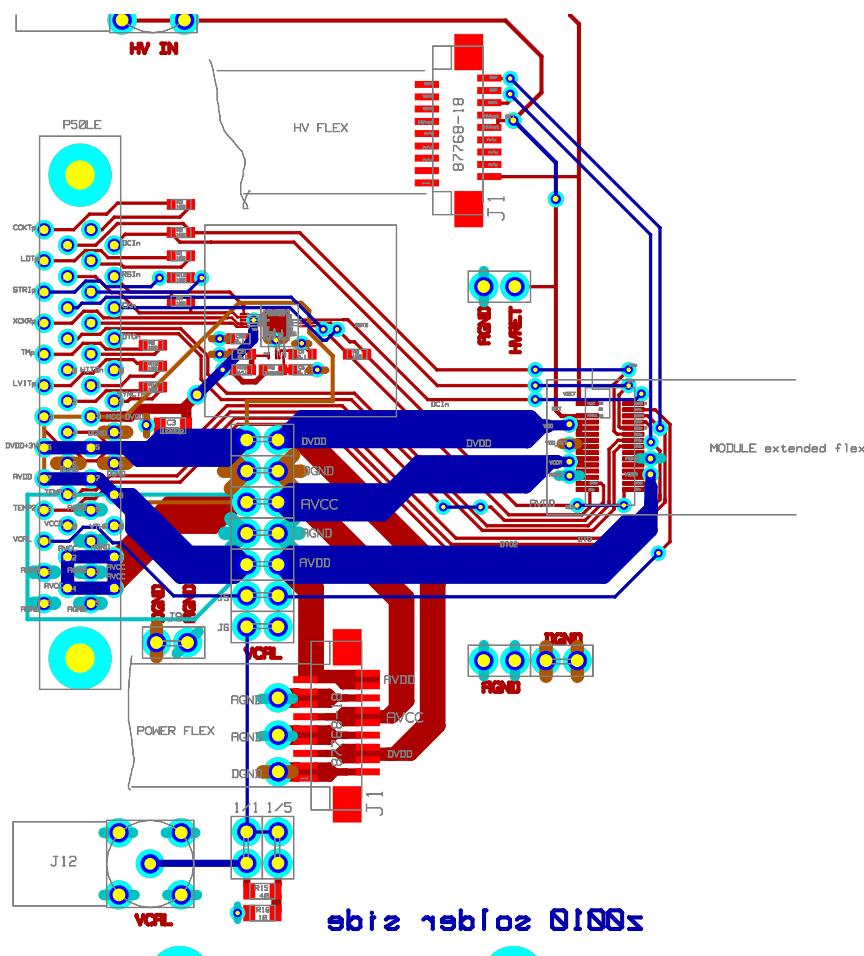
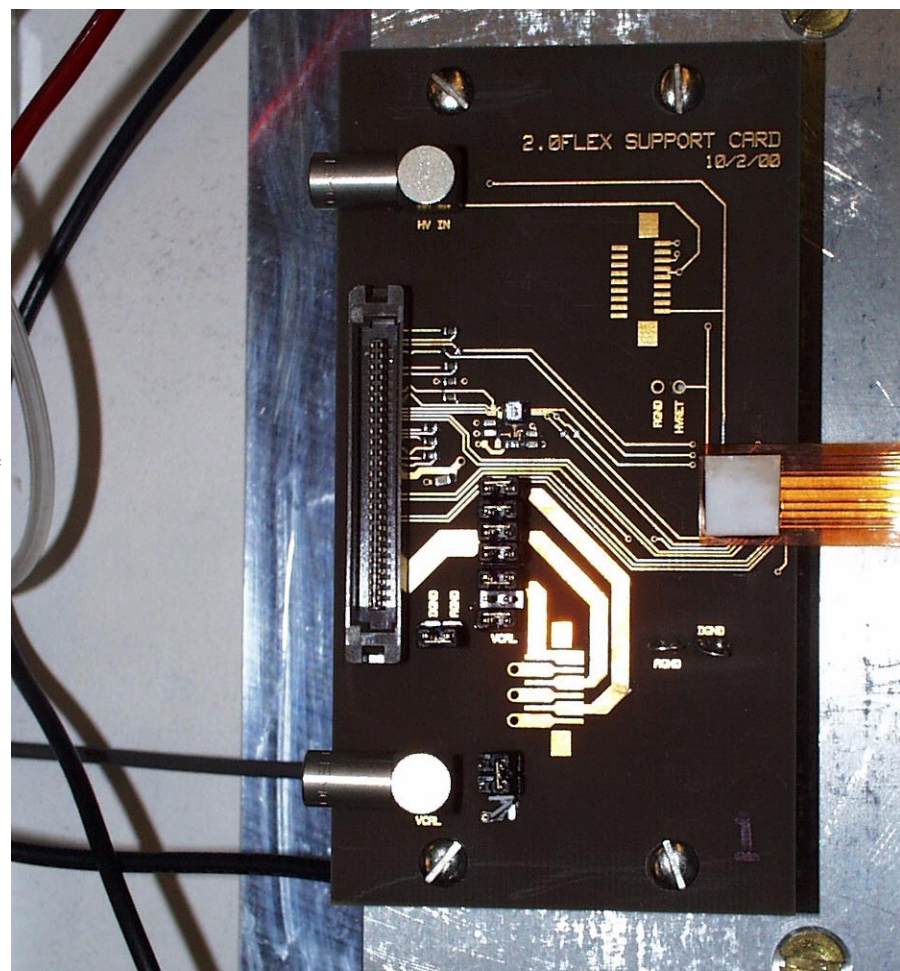
### Mini-support Card:

- Smaller version of single chip support card. Contains rad-hard LVDS buffer, pads and jumpers to allow mounting Berg connectors for attaching prototype power cables, plus usual support card features (HV connection and VCal connection via LEMO, VTH/VCCD jumpers...)

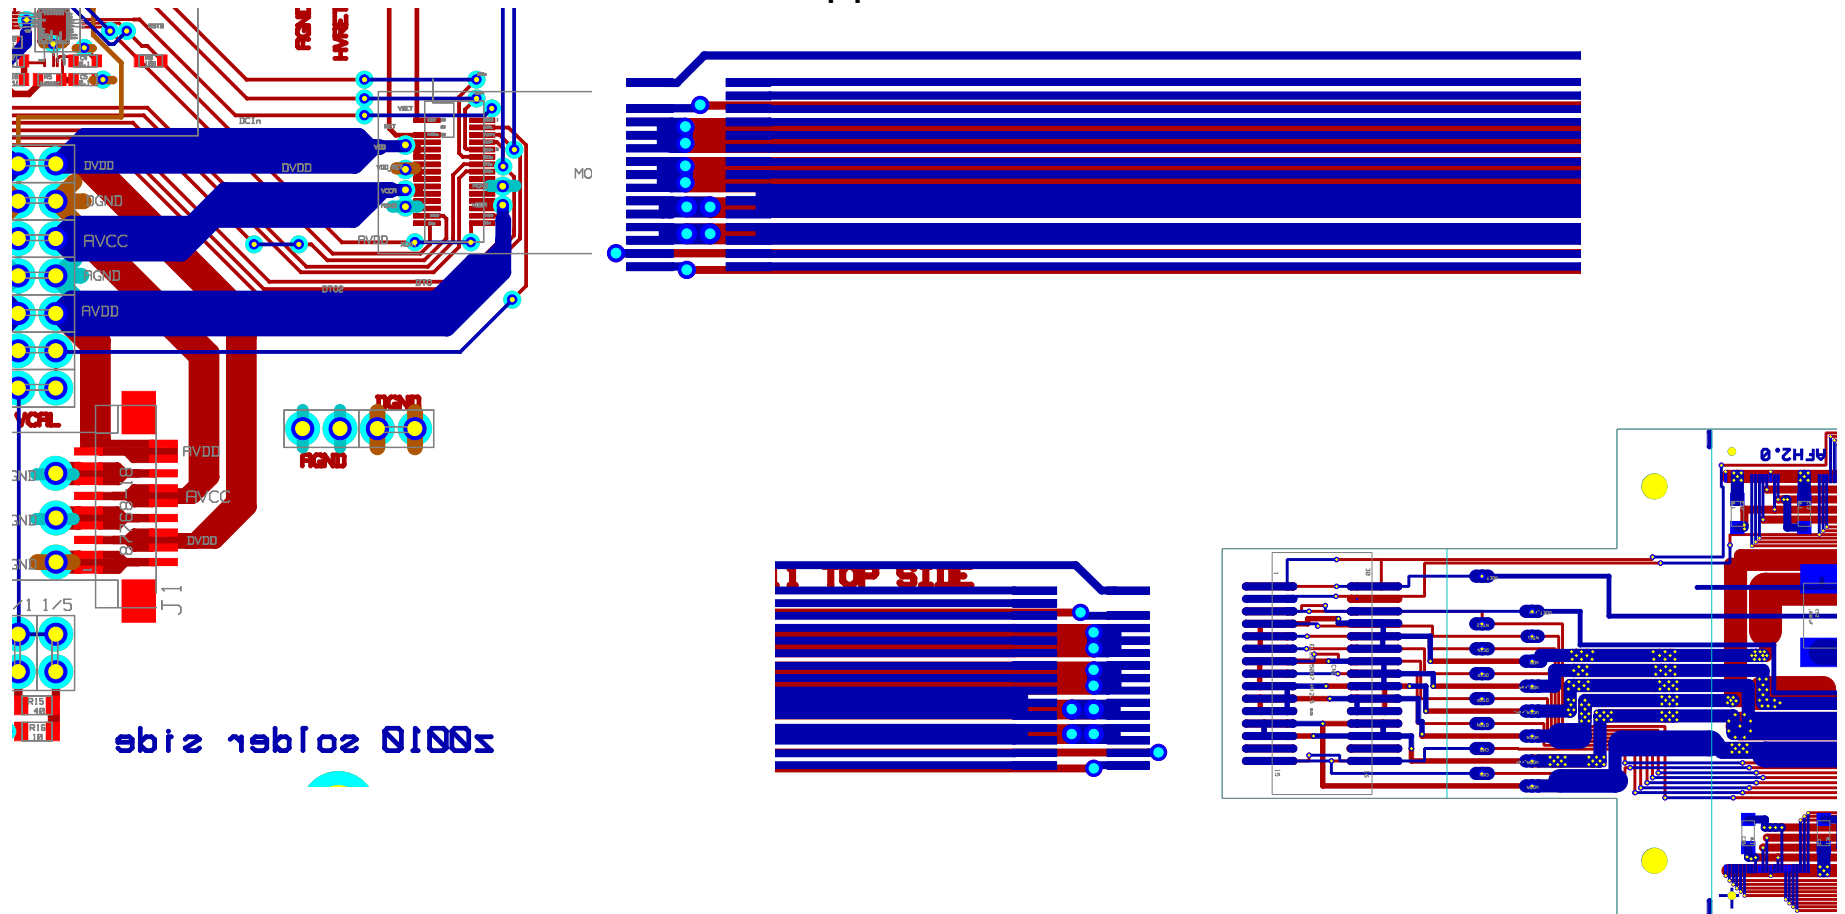
## Jumper Cable:

- Flex cable acting as short pigtail prototype (15cm length). Double sided for power and signal connections, fabricated from 1oz (35μ) Cu for lower voltage drops.
- Supports connection between 30-pin Elco 5087 mounted on Flex 2 test connector and similar connector on Mini-Support Card.

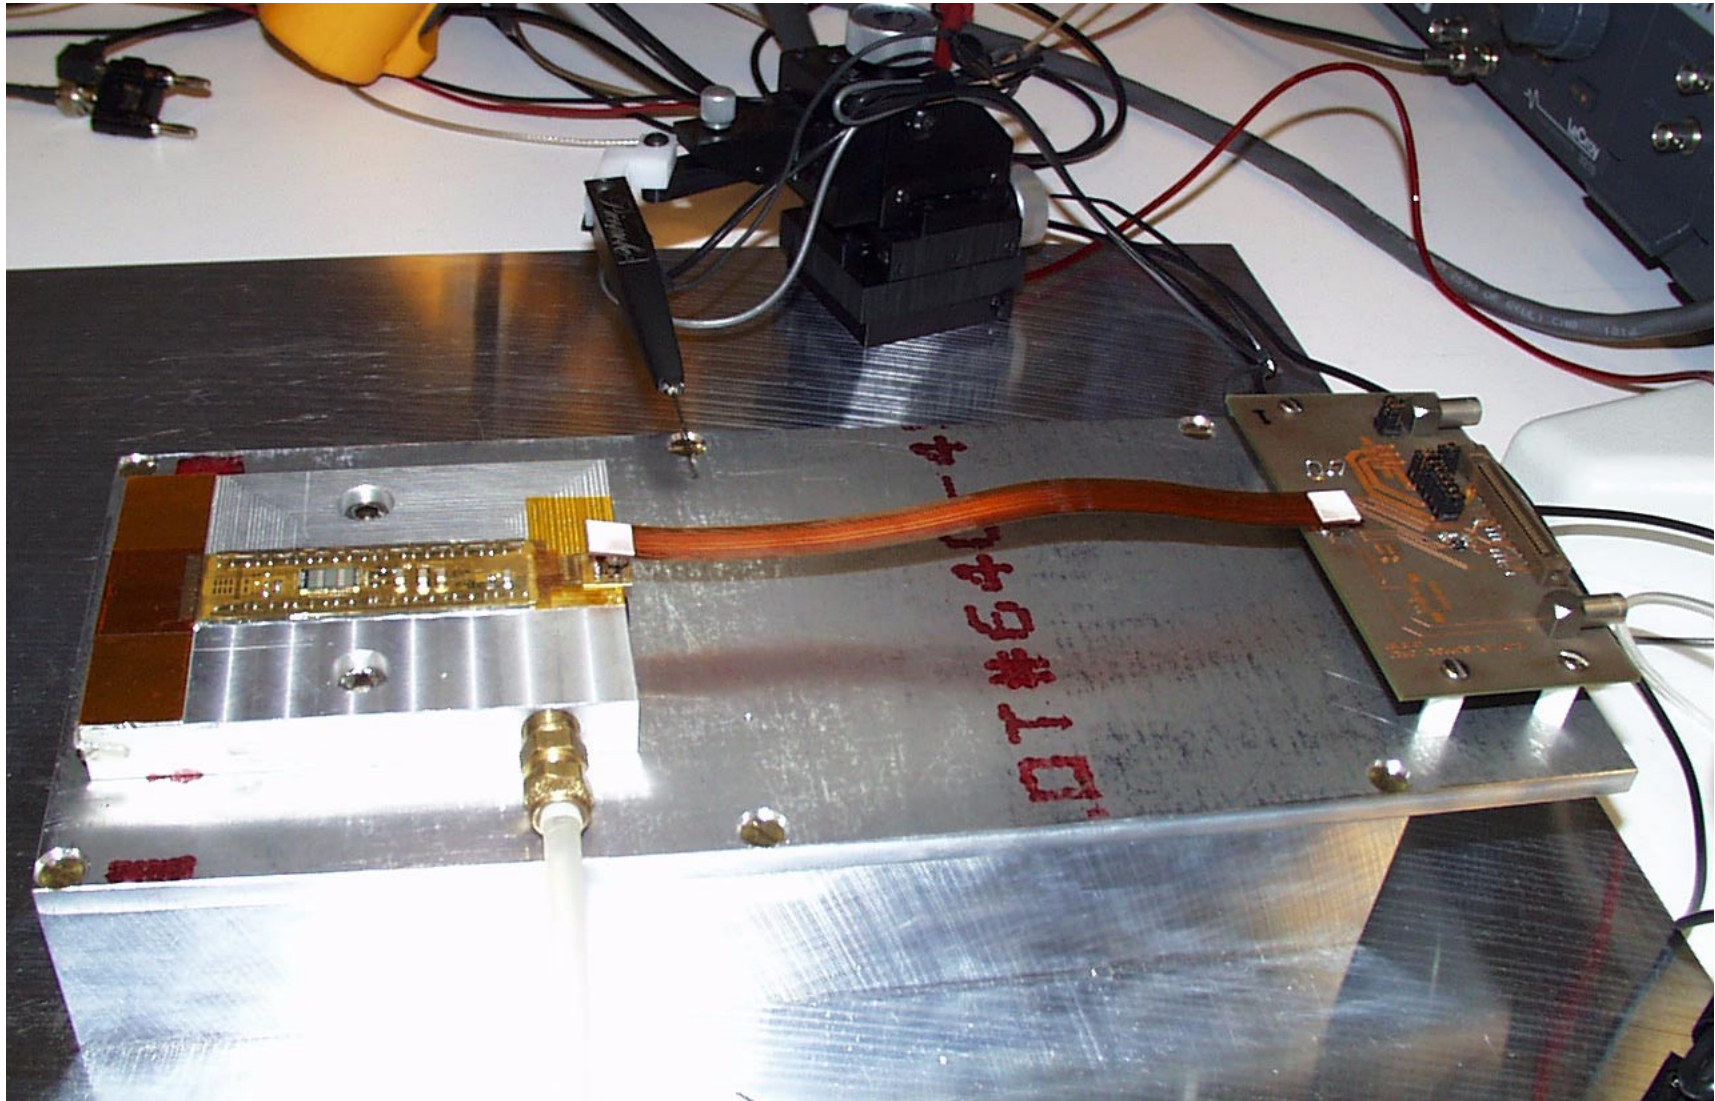
## Complete setup mounted on support plate:

- Module mounted on vacuum chuck, containing 4 small holes per FE chip. Also used for probing of bare module prior to attachment of Flex.
